Manhole Inspection Summary

Manhole # S25EE1032MH

Location Address: **3912 FALLS RD**

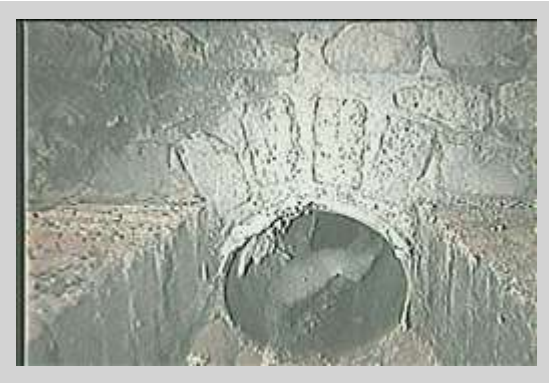
8 in. Circular Gravity Sewer Pipe Out @ 12 O'Clock

Invert Depth: **12.78** (ft.) Flow Characteristics: **Fast**

Deposits: ☒ None ☐ Mud ☐ Sludge ☐ Debris ☐ Grease

Infiltration: **None** Pipe Seal Cond: **Unknown**

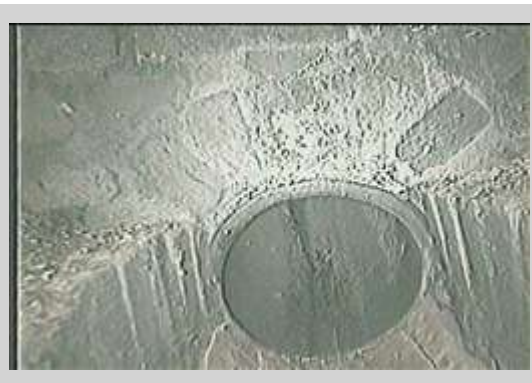
Drop In @ 6 O'Clock

Drop: **Outside** Rod and Bar

Angled: **Yes** Reading: **11.55** (ft.)

Drop Condition: **Open**
